WILD TROUT TRUST

Advisory Visit

River Rhee, Haslingfield, Cambridgeshire

October 2025

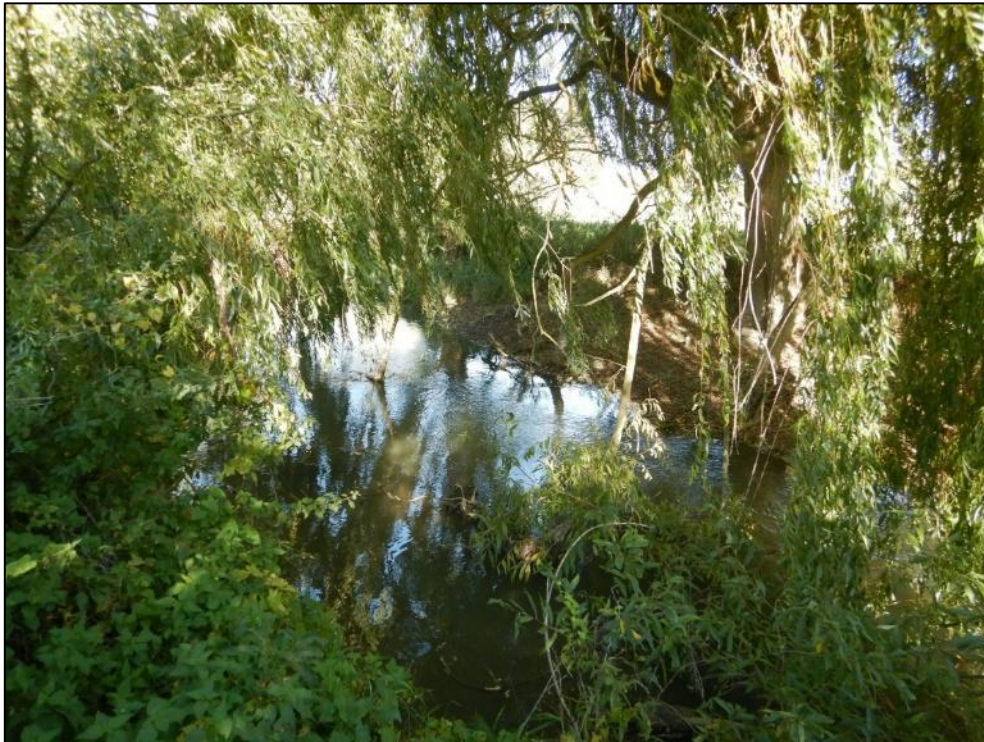
Pic 1 – The visited started where the river was overhung by a weeping willow from the right bank downstream of the Harston Road bridge. Several of the weeping willow limbs had set roots into the water.

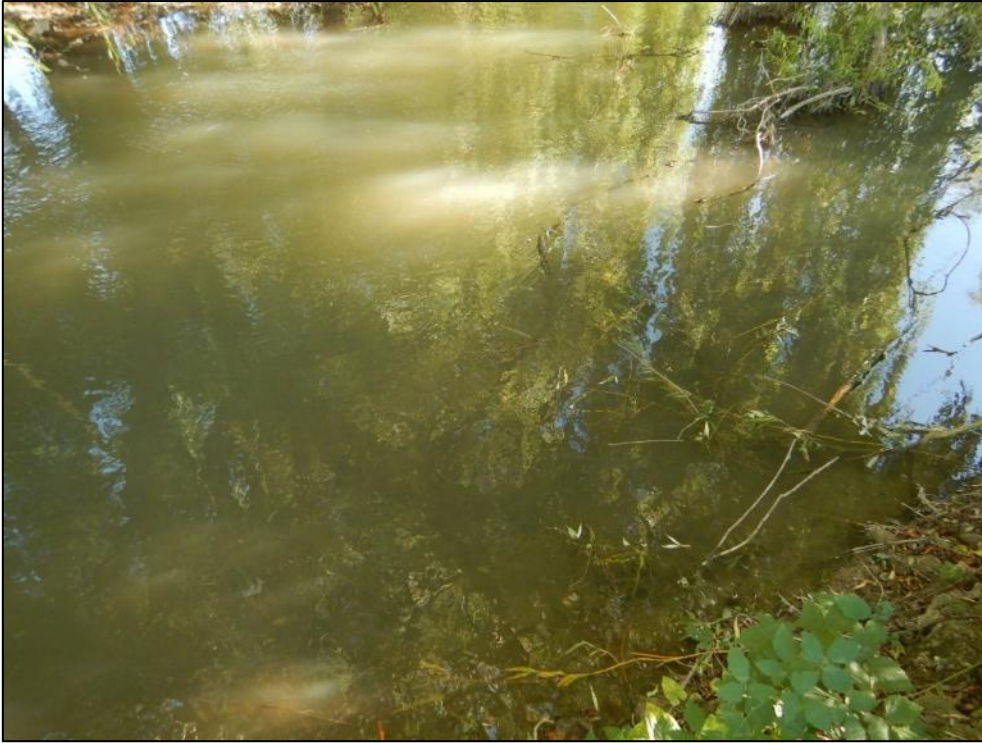
Pic 2 – Turbidity was extremely high, with visibility into the water little more than 30cm.

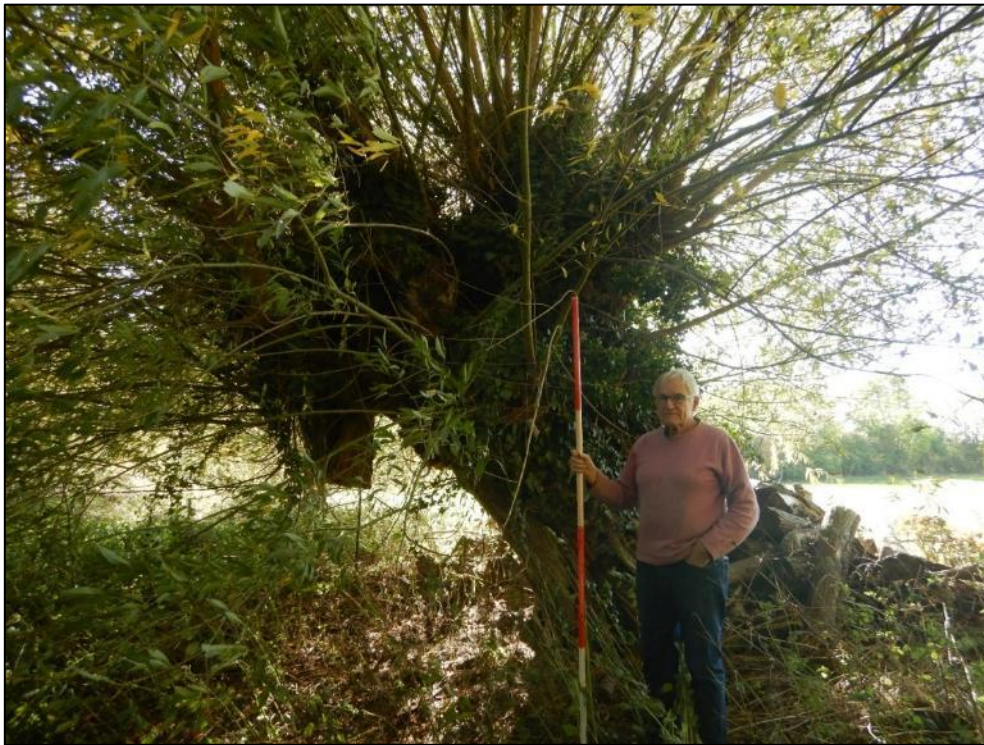
The first of more than 10 very large veteran pollard willows was observed at 52.140160, 0.069554 (pic 3). This tree had been recently re-pollarded, but many others had been allowed to collapse as part of their natural aging process. There are benefits to re-pollarding including occasional periods of

Pic 3 - Veteran pollard willow.

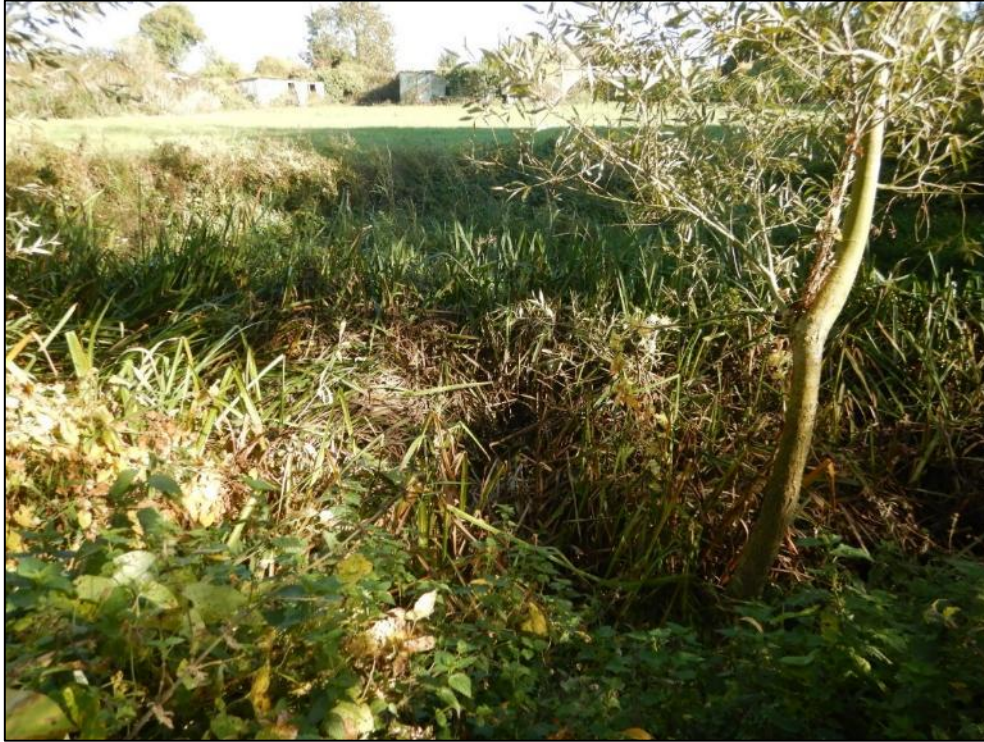
A significant stand of bur reed was noted at 52.140295, 0.069598 (pic 4). The plant was once confined to the margins, and the open channel was wide with flow moving swiftly over a shallow gravel bed. Over time the channel has adjusted because of the downstream transport of fine sediment, which has accumulated over fallen woody material. Water velocity has reduced allowing the bur reed to establish its dominance, resulting in further slowing of the flow and channel narrowing. At the time of visit the channel had been narrowed to ~2m with flow concentrated against the right bank (pic 5). In the open aspect, marginal vegetation (mainly of water forget-me-not and reed sweetgrass) held the bank firm and prevented fine sediment from washing in. This kind of narrowing and further incision often occurs in over-capacity channels where the bed has

been lowered. It is then very difficult for a river to recover a natural morphology without significant introduction of coarse sediment; this may not occur naturally, particularly if there is limited supply from predominantly fine sediment (alluvial) banks.

Pic 4 – A stand of bur reed almost engulfed the channel where the river once flowed swiftly.

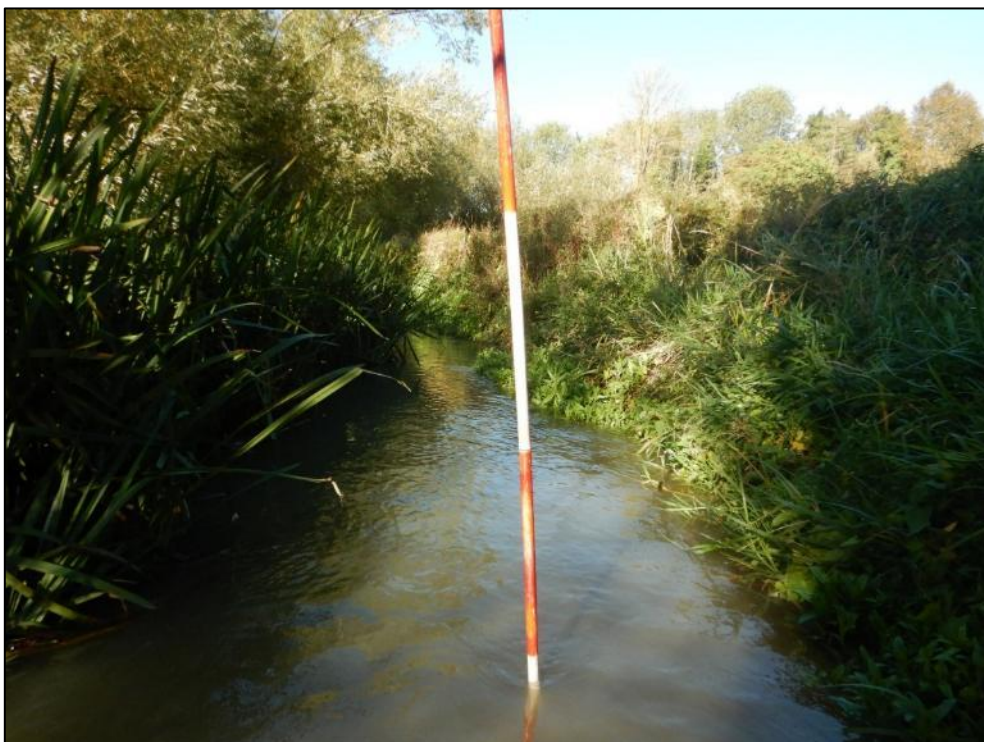
Pic 5 – Where light reached the right bank vegetation gave it strength and narrowed the channel.

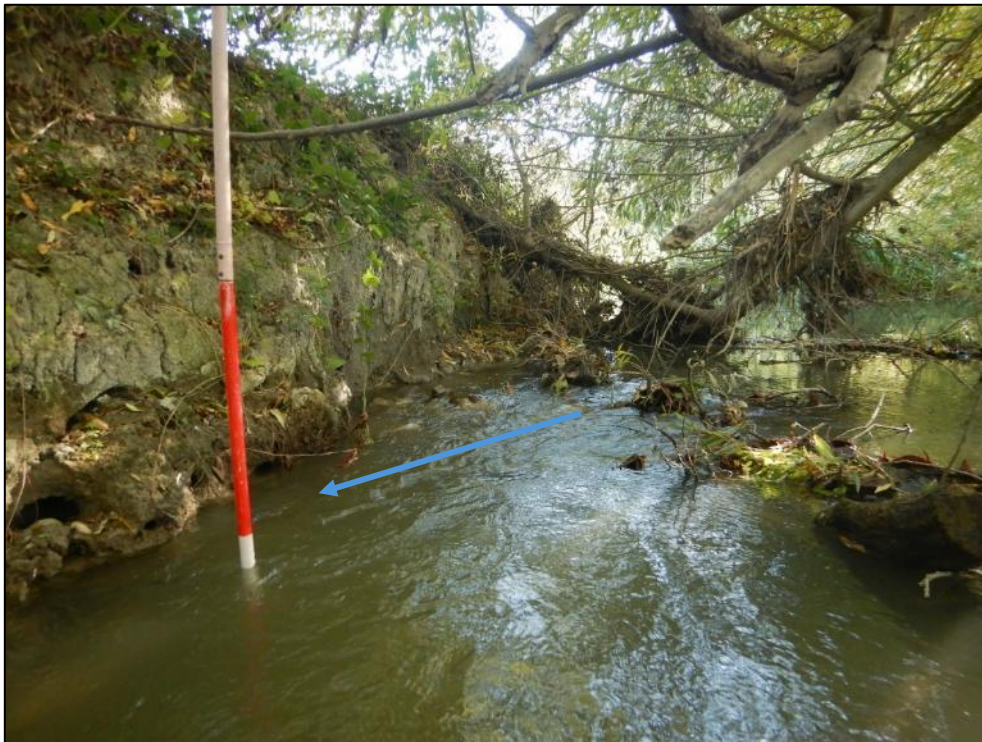
Pic 6 - Flow was being pushed against the weak alluvial bank.

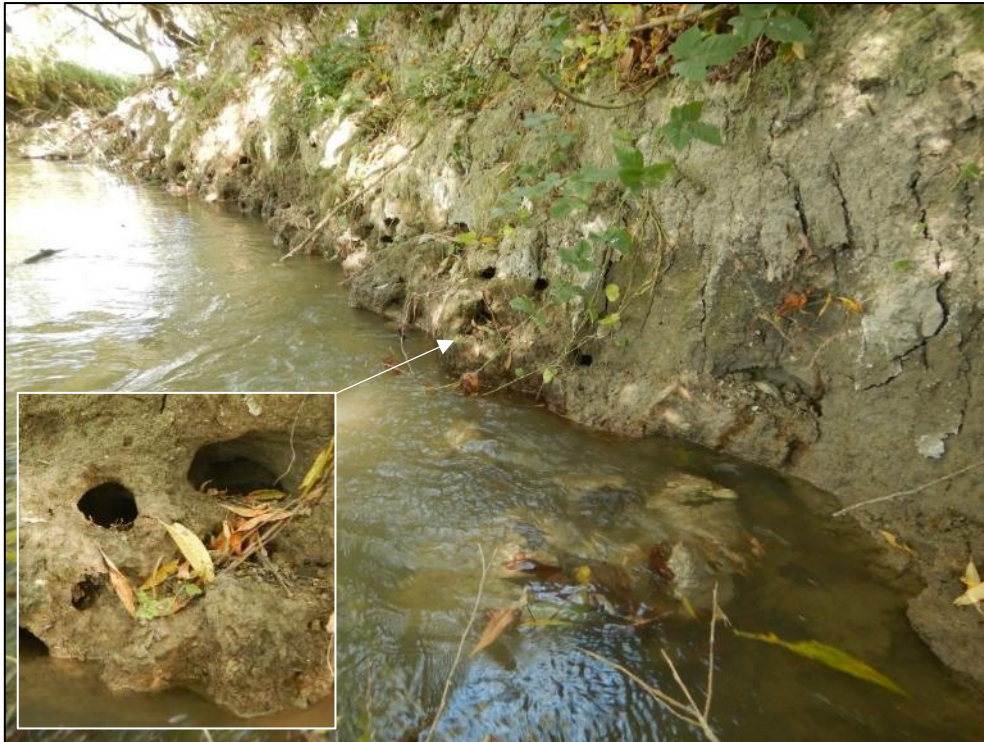
Pic 7 - Crayfish galleries resulting in block failure of the bank. Crayfish burrows shown inset.

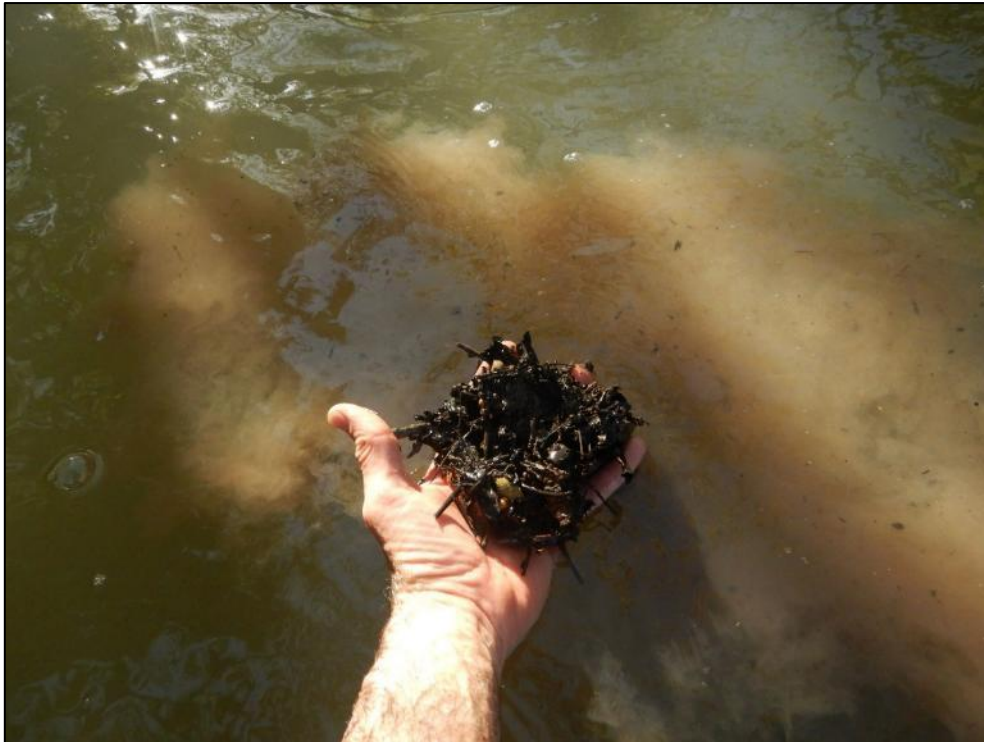
Walking on the riverbed released a high volume of fine sediment (as expected) but investigation by hand revealed a high volume of organic matter, most of which appeared to have originated from (willow) trees (small twigs, catkins and leaves, pic 8). Encouragingly, there were large numbers of freshwater shrimp (*Gammarus* sp.) breaking down the matter. The input of naturally occurring organic matter to a river is normally to be welcomed, but in this instance, one must wonder just how much lays at the bottom of the river, and whether it is being cleansed by a through flow of water, or whether it is simply accumulating year on year (if entering anaerobic conditions). Note the gas bubbles in the picture. Further inspection of the bed substrate beneath the organic matter revealed fine sediment mainly of sand, grit and small (~5mm) gravel (all particles of a size that the river can transport by its flow).

Pic 8 – A very large volume of organic material had accumulated on the riverbed.

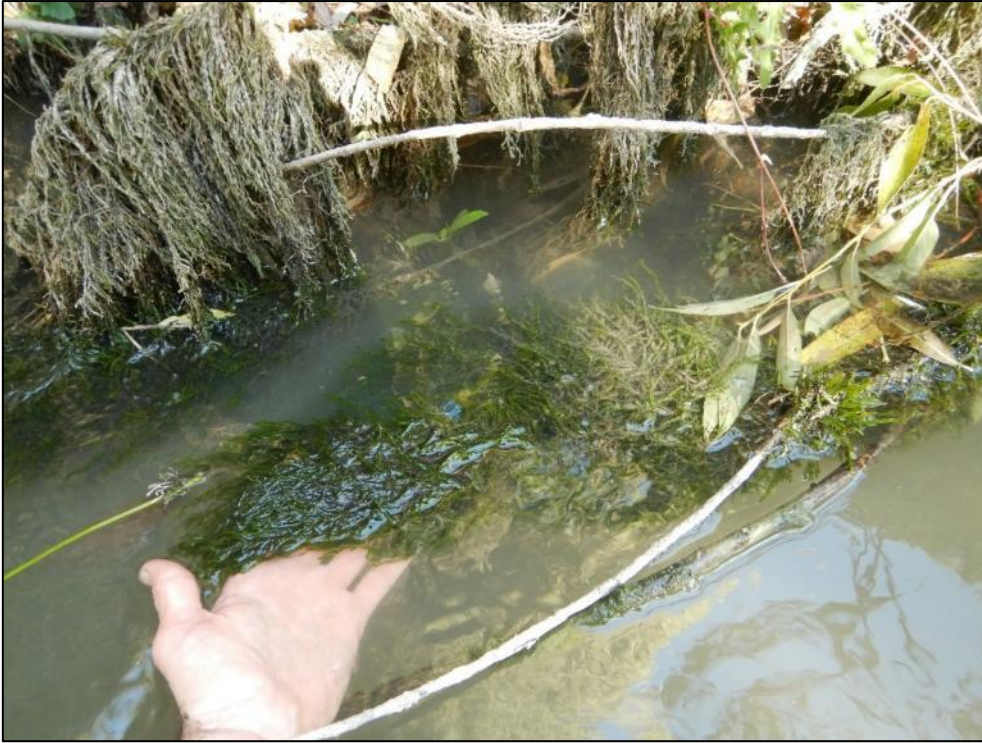
Whilst the diversity and abundance of aquatic plants is reduced from that known 20 years back, it was pleasing to observe willow moss (pic 9) growing attached to willow roots suspended in the river's surface layer. Without trailing branches this plant would not find a niche. The plant favours cool water with a medium to fast pace. Its trailing stems and leaves provide a substrate for fish such as perch and roach to spawn upon, and for aquatic invertebrates to shelter amongst. The former gravel run below the Harston Road bridge was once dominated by water crowfoot (a chalk river indicator species) and arrowhead grew abundantly by late summer together with unbranched bur reed. High water turbidity, and the action of crayfish is now considered to adversely affect aquatic plant growth.

Pic 9 - Willow moss growing attached to trailing willow limbs.

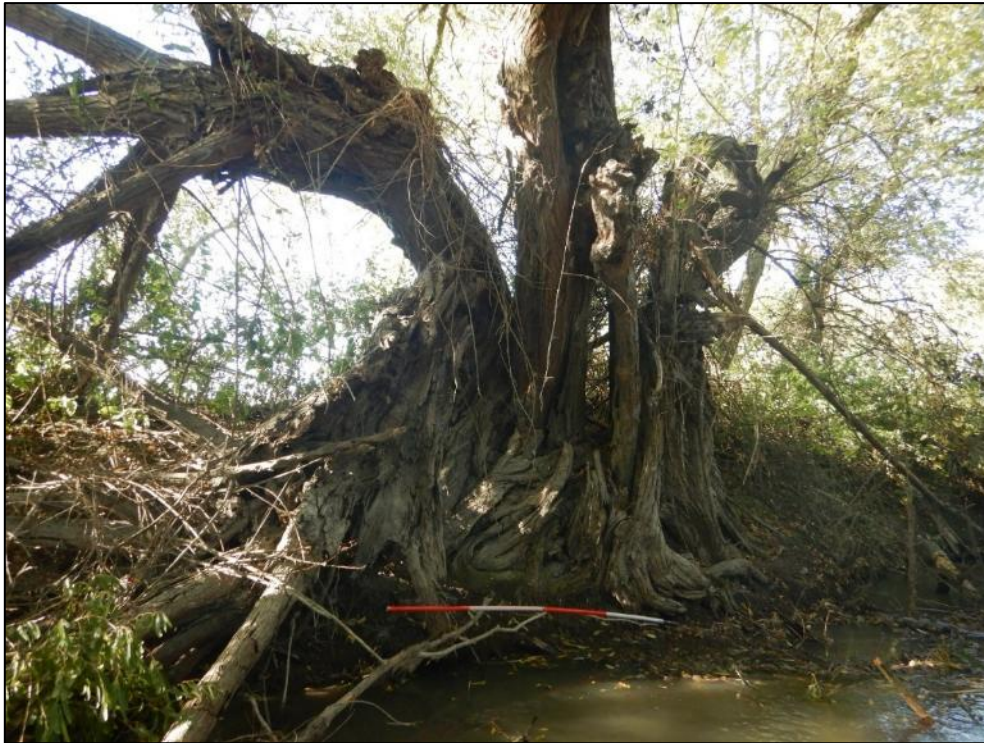
Another very large veteran pollard willow was observed at 52.140564, 0.069554 (pic 10). Although in state of decline, its roots still held the bank strong, and its branches provided a source of important large woody material (LWM) to the river. The occurrence of fallen branches, together with the organic matter that they collect, may look unsightly to some but the presence of LWM is of great importance within rivers. LWM leads to an increase in the surface area on to which a biofilm (algae, bacteria and other microbes) can grow. Where LWM presents no flood risk it should be retained as it improves hydraulic roughness within the channel and, as water is forced around and under, it can initiate bed scour. Fallen LWM can also provide cover to fish from predators. Where possible, fallen trees and timber should be secured in river margins to increase habitat and cover.

Pic 10 - Another very large veteran pollard willow.

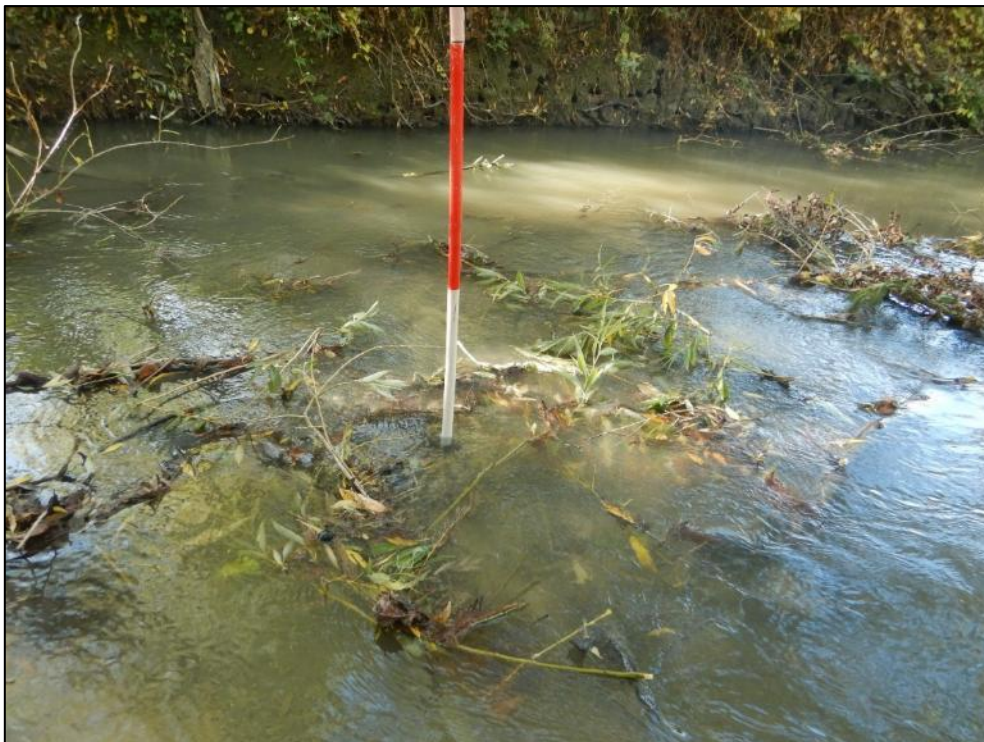
With the branches of the veteran willows rooting in the channel, areas of slower water were created, and at one occurrence a mid-channel bar of fine sediment had accumulated (52.140699, 0.069686 pic 11). Whilst it is desirable to see the formation of in-river features bringing diversity to flow and river form, it is a sad reflection of the river's current state: one which is overburdened with fine sediment and can only create features which are transient. In the distant past the river would have been supplied with coarse sediment (gravel and cobbles) together with its fine sediment as a result of erosion of the riverbed and banks. This material would have been transported downstream to form natural occurrences of riffles and gravel bars, which would have provided areas of shallow and fast-moving water, leading to deeper pools and scoured meanders. The challenge of the river trying to restore itself with fine sediment is that most features are prone to

Pic 11 - A mid-channel bar of fine sediment.

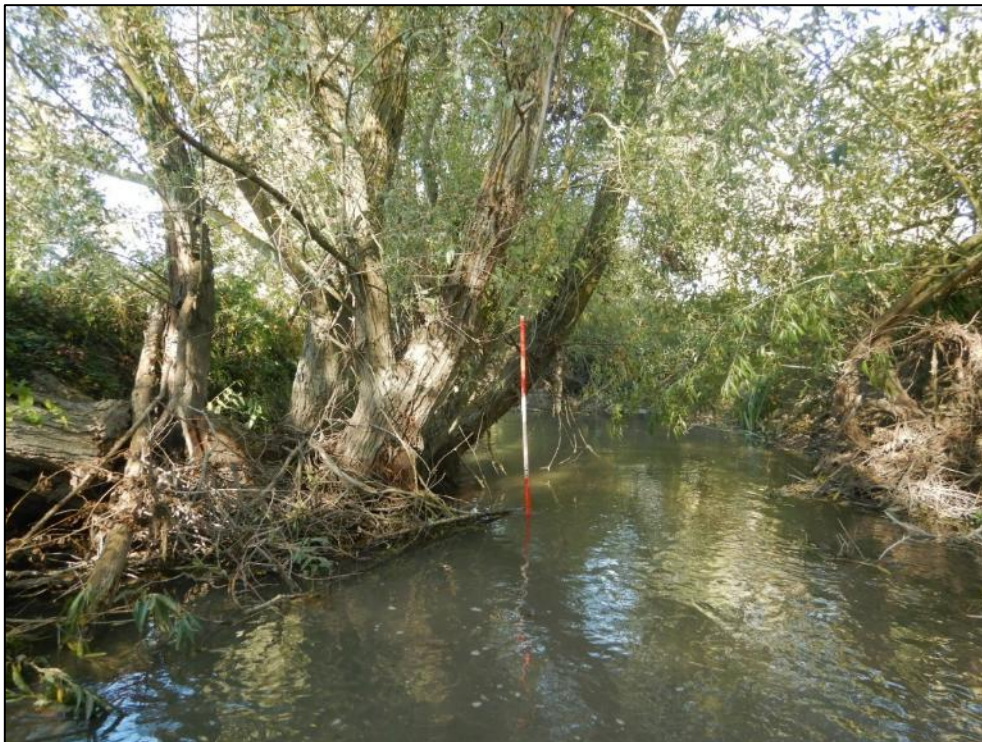
Due to the permanence of a large willow which grew low from the left bank (52.140834, 0.069730), flow was deflected to the centre of the channel resulting in depth creation and maintenance (pic 12). The depth was $\sim 0.8\text{m}$, and in combination with the cover provided by the tree, is likely to harbour adult fish, especially trout and chub. The high, but strong, canopy of a willow that had not been too frequently pollarded, retained shade and high cover over the water. Shade over rivers is becoming increasingly important as hotter summer temperatures are experienced. A further benefit of trees over rivers is the terrestrial invertebrates that occupy them, which may ultimately fall to the river below to become prey for fish.

Pic 12 - Flow deflection by the willow has maintained pool depth by flushing through fine sediment.

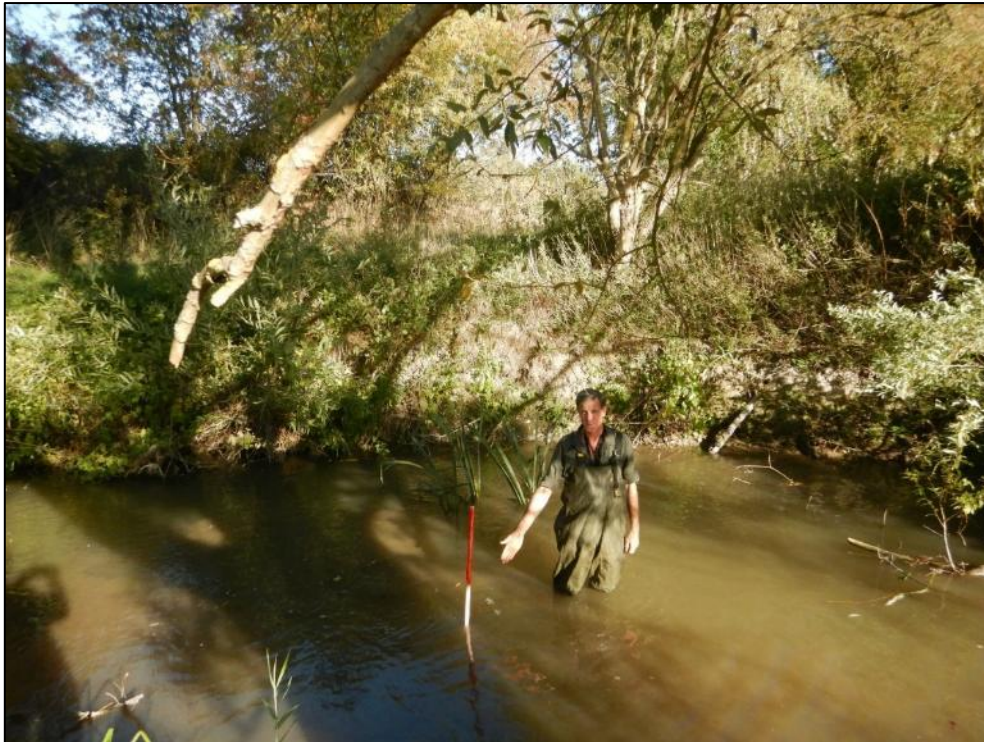
Approximately 40m before the first significant meander, the bed was noted to rise again. This is not how the river used to be. Although formed from fine sediment (mainly sand) it could support the author's weight. The ranging pole was pushed down into the sediment, revealing an accumulation depth of $\sim 0.8\text{m}$, with $\sim 0.3\text{m}$ of open water above (pic 13).

Pic 13 – The author supported on ~0.8m of firm fine sediment.

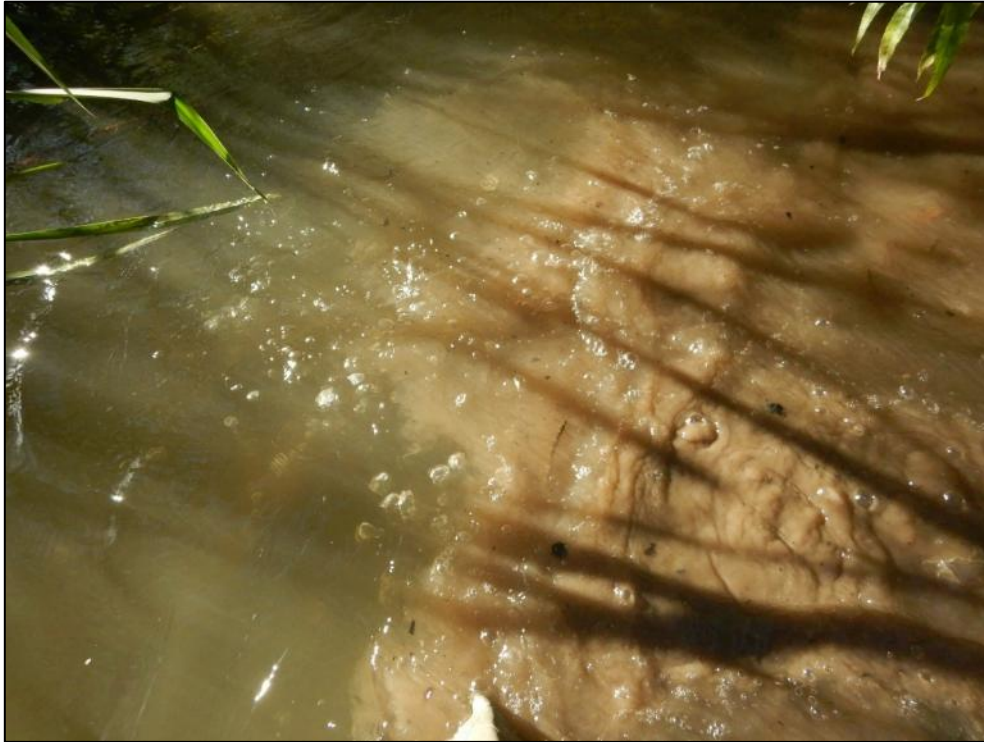
Concerningly, when the sediment was kicked about, large volumes of anaerobic gases were released (pic 14). One has to wonder if the slow release of (harmful?) gases from the riverbed may make the reach less desirable for fish, especially in low flow summers with excessively high temperatures when dissolved oxygen levels would be naturally lower. This may be a factor affecting fish distribution in the river and may account for

Pic 14 - Kicking the bed released a large volume of foul-smelling gas.

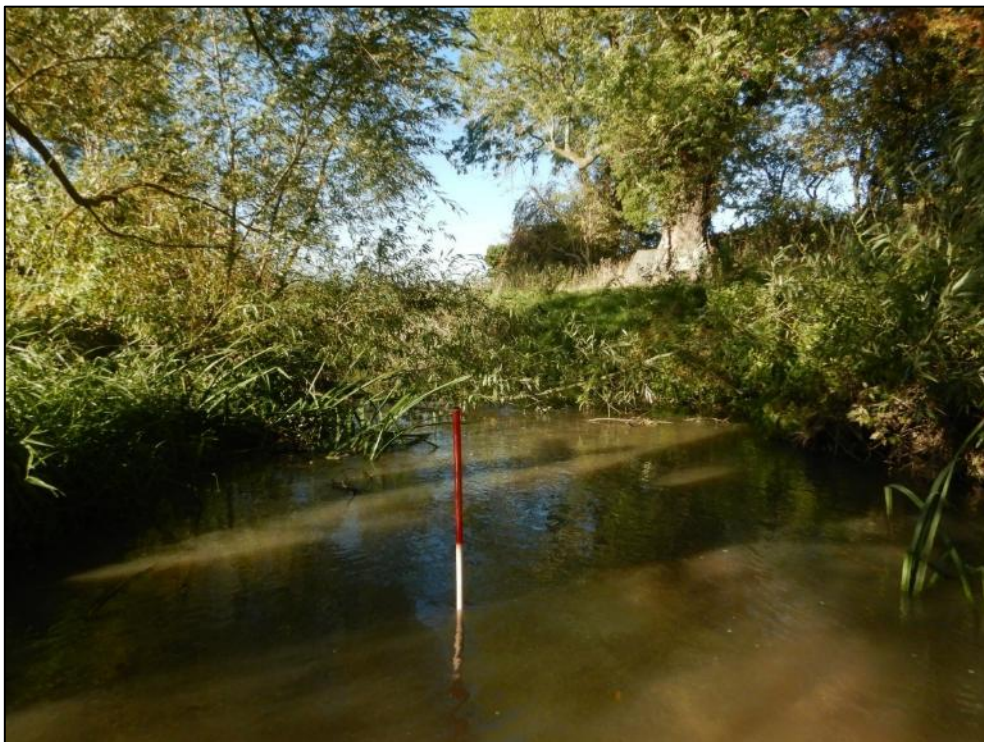
local anglers stating that certain reaches appear to contain few larger fish anymore (larger fish have higher oxygen demands, as do species such as brown trout). After the long 'sand bar' the depth returned to what was expected, ~1.2m.

Pic 15 – Once the fine sediment deposition reduced, depth was established once again.

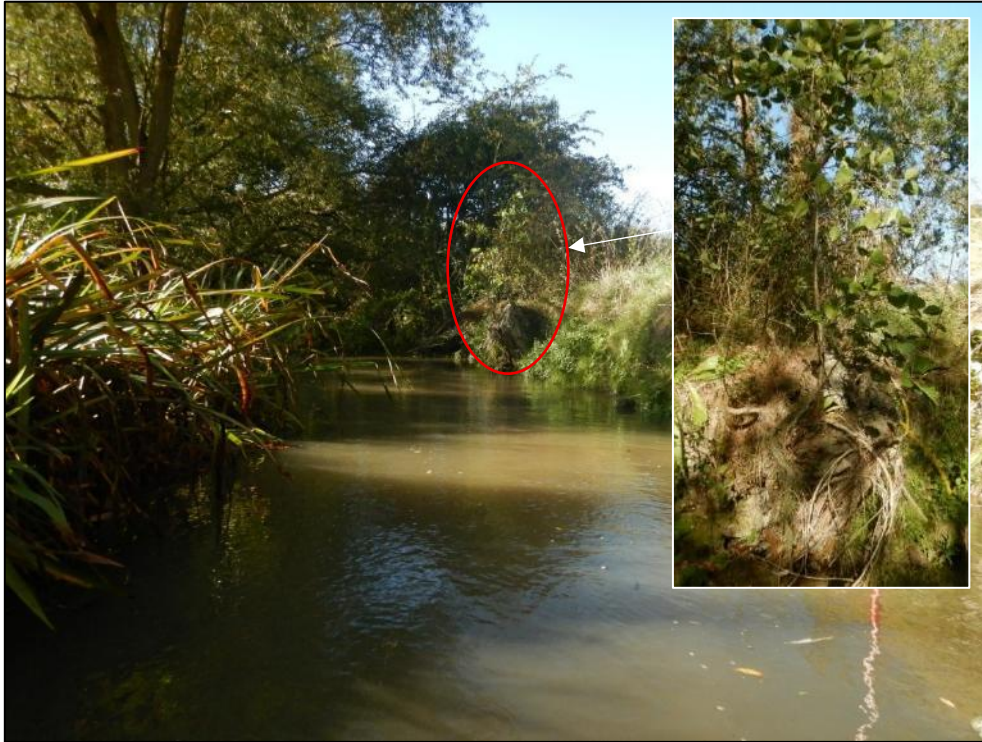
Pic 16 – A common alder was observed. Alder roots are excellent for stabilising banks and should be included in future planting schemes.

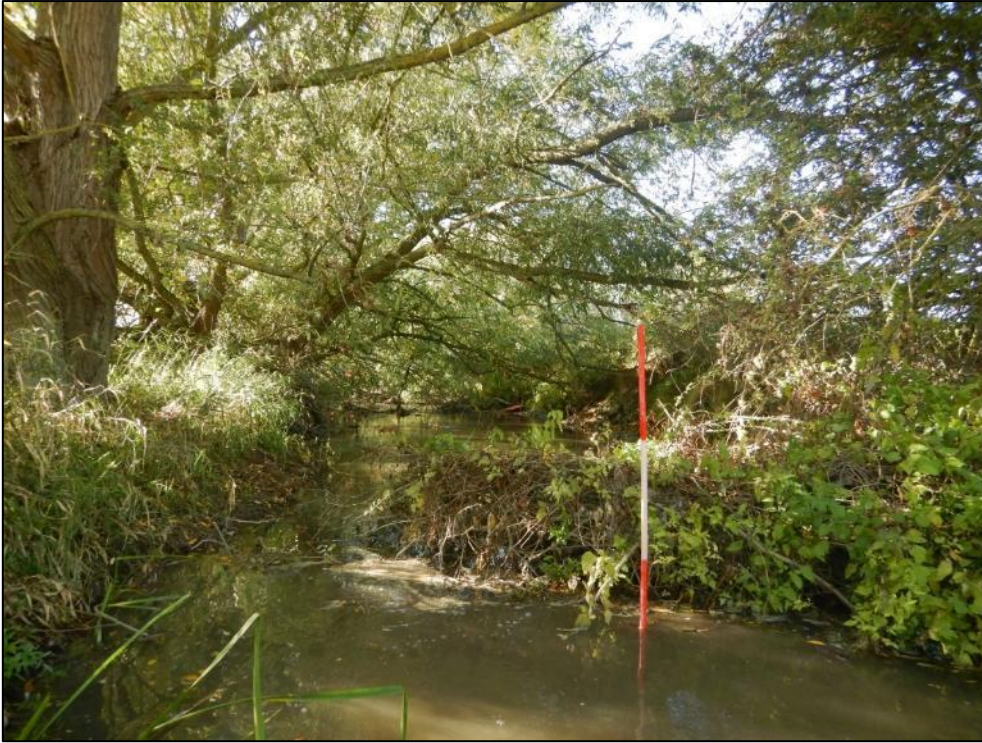
The channel became dominated by a random assortment of fallen wood and willow branches once again, with the main flow pathway partially obstructed by woody nightshade binding material together (pic 17). Once the fallen material was passed the flow pathway returned to the centre of channel and marginal growth of bur reed occurred (pic 18).

Pic 17 – The channel was dominated by fallen material once again (52.141157, 0.069642).

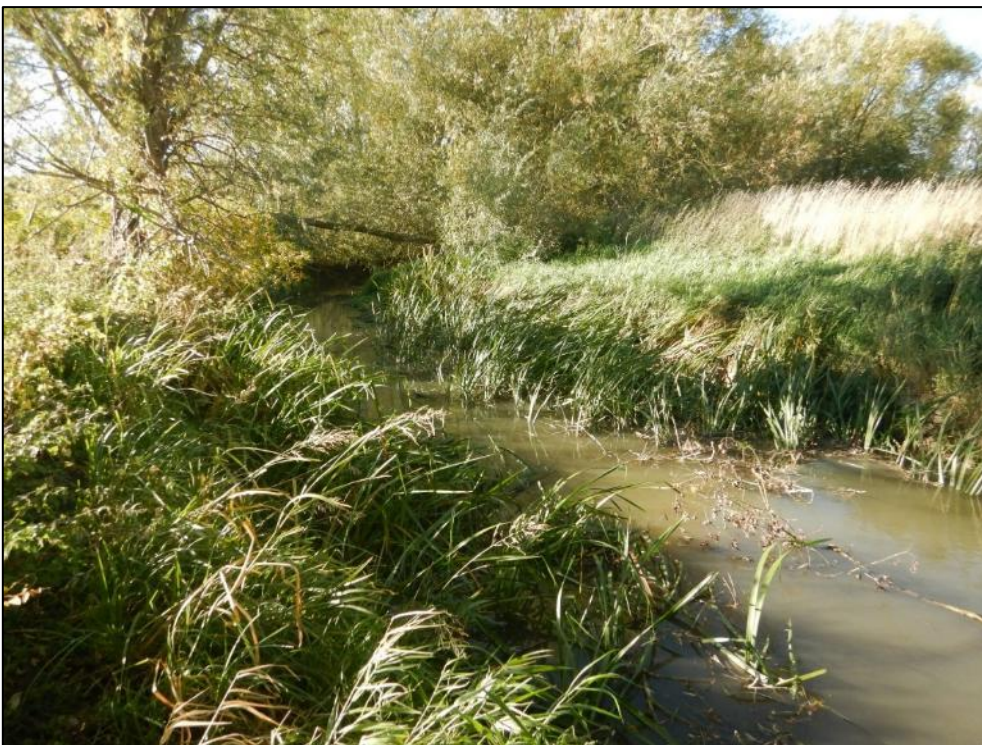
Pic 18 – Bur reed growing as marginal plants suggesting mid-channel scouring of fine sediment.

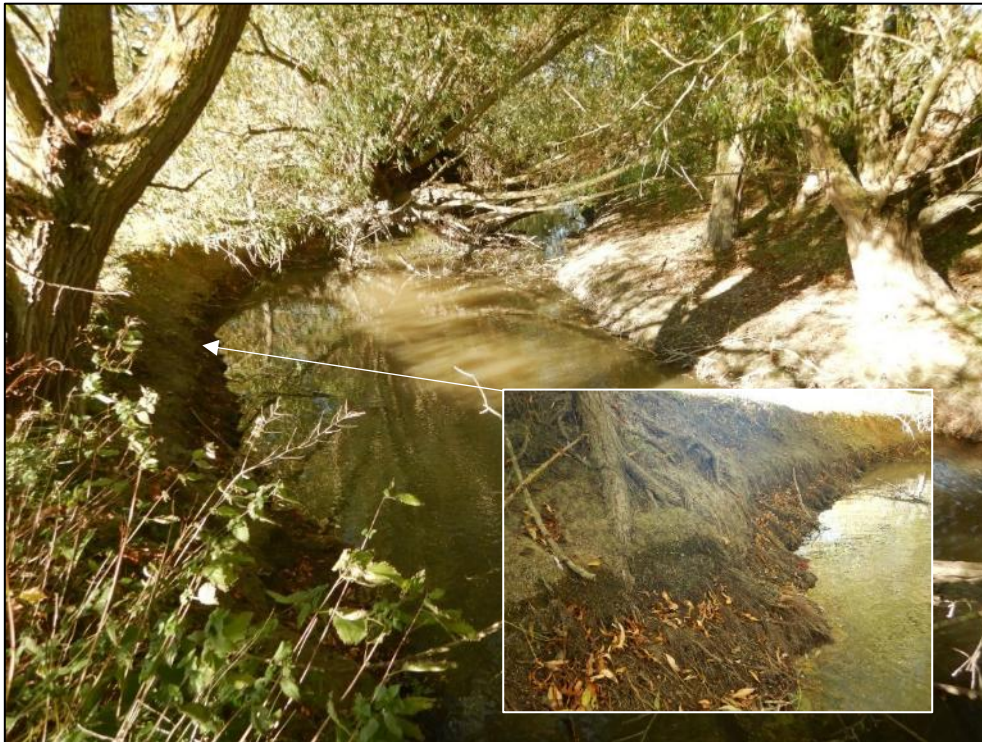
Turning another meander, willow tree roots held the bank firm (52.141535, 0.068675 pic 19). Willows can effectively lock a river in its current state, if that state is one of poor-quality habitat, then that will be maintained. In a naturally diverse and active river, fresh supplies of gravel would be transported downstream from eroding gravel beds and banks, but the Rhee

has had its gravel bed almost completely removed and the alluvial banks erode only to add further fine sediment to the system which is massively overburdened.

Pic 19 – Willow roots hold the bank firm.

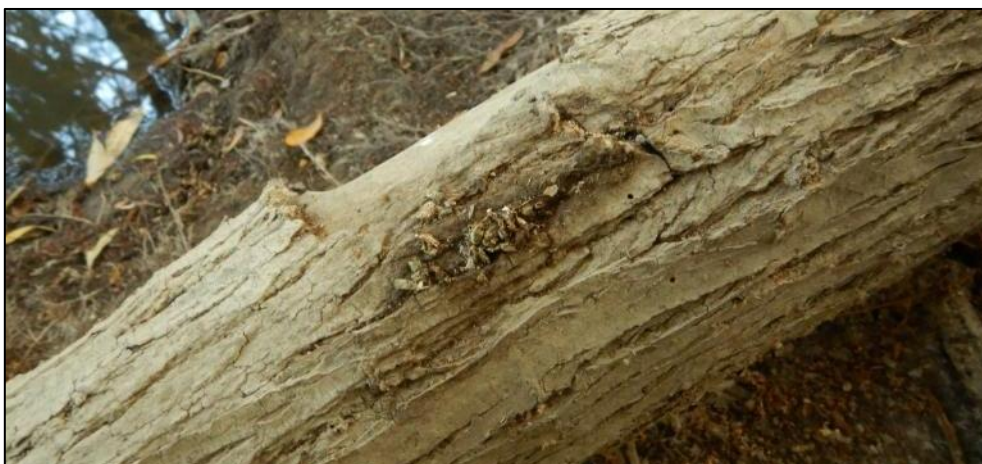
Amongst cover afforded by the willows and their collapsing branches, otter spraints were found. Although old and dried, it was possible to see fragments of crayfish carapace and occasional fish bones (pic 20). Otters have been present in the Rhee catchment since the early 1990s. A possible artificial holt, with a pipe entrance, was observed at 52.145146, 0.066302 (pic 21). The now defunct Cambridge Greenbelt Project embarked on a programme of holt building to aid the species' recovery.

Pic 20 - Otter spraint on a fallen willow branch.

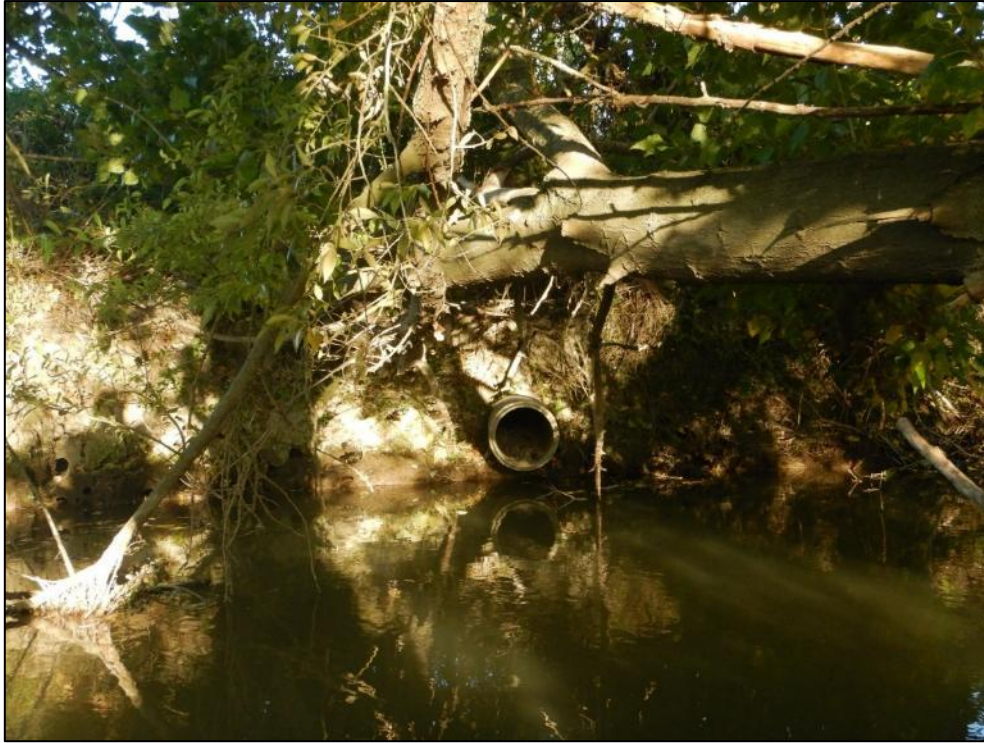
Pic 21 – A pipe, possibly leading to an artificial otter holt.

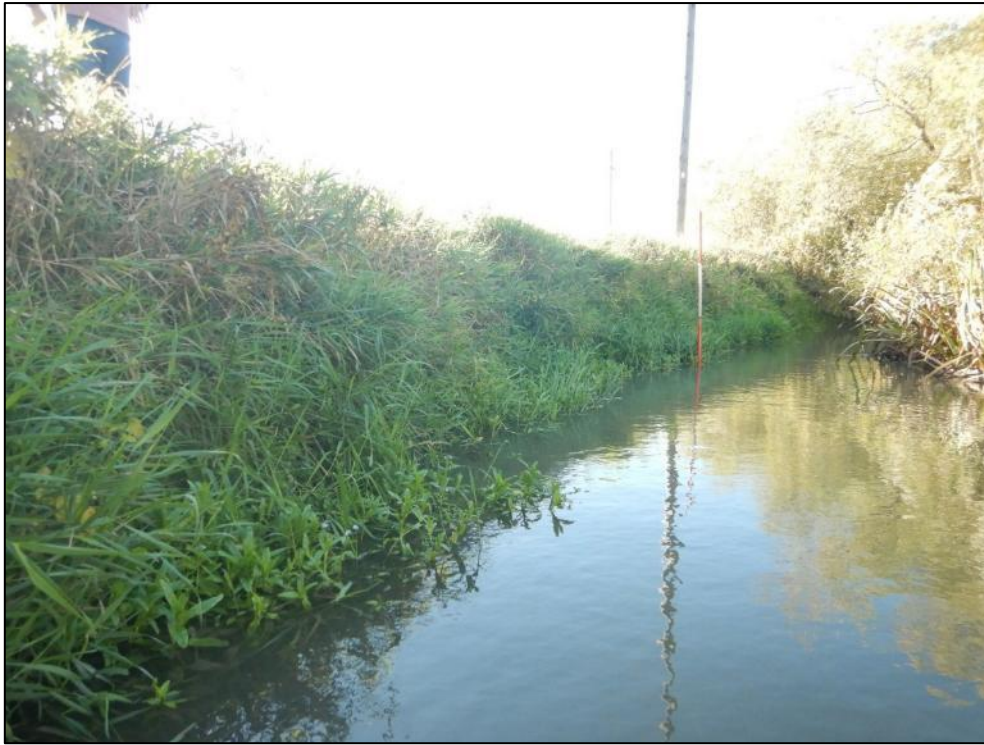
Where the grade of the left bank was not too steep and it received light, it was covered by dense marginal growth of reeds and grasses. This is encouraging as it may be possible to re-grade banks to encourage vegetation regrowth and limit the extent of bank collapse, and ultimately fine sediment input.

Pic 21 - Where light reached the bank vegetation was established.

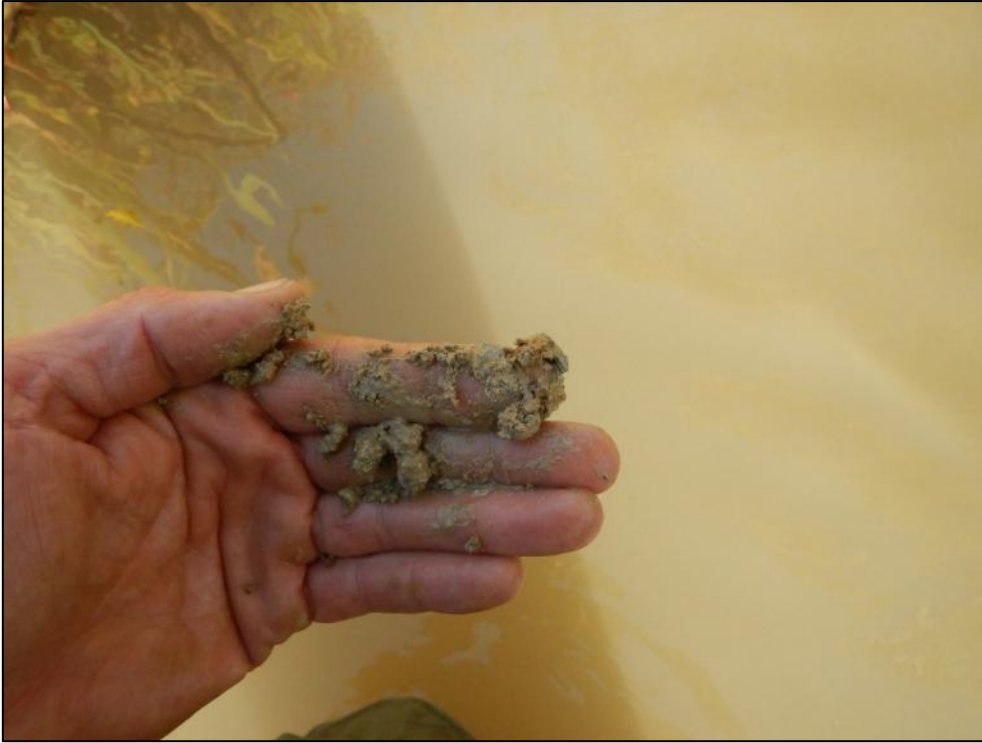
Further investigation of the riverbed where it shallowed once again (to $\sim 0.4\text{m}$) revealed little coarse substrate. Instead, a sample of gault clay was lifted (52.141508, 0.068675 pic 22). The Rhee is categorised as a chalk river, but with its gravel bed removed, erosion has now exposed gault clay. Fine clay particles are easily mobilised and held in suspension. In the last ~ 20 years the signal crayfish population has exploded in the Barrington to Harston reach; the constant activity of possibly millions of crayfish is constantly mobilising even more clay particles than would naturally occur. It is the author's view that the action of invasive crayfish (undertaking a form of bioturbation), in combination with past dredging, has created conditions for high turbidity to prevail. This phenomenon is currently being investigated by different parties including the Cam Catchment Partnership ([Sediment and Turbidity – Cam Catchment Partnership](#)) and the Cam Valley Forum ([22049-final-CVF-Turbidity-Summary-2025-03-31-.pdf](#)). It is quite possible that a number of pressures are compounding to cause turbidity in different ways. Decomposing organic matter can also contribute to water turbidity.

Pic 22 - Gault clay lifted from the bed of the river.

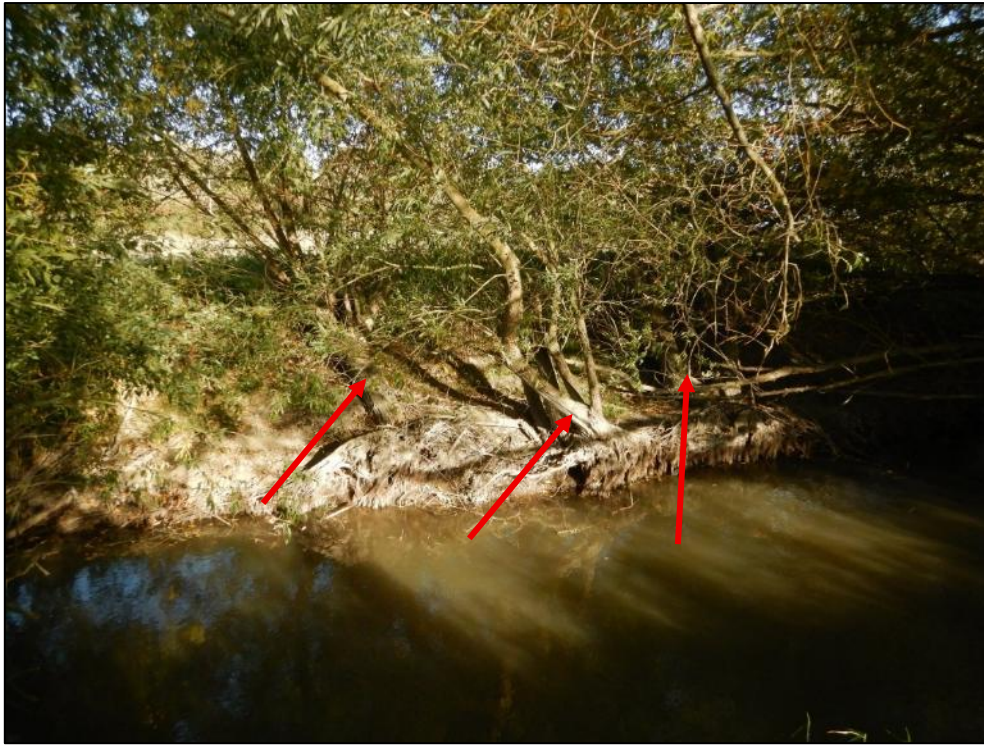
This report has highlighted examples of willow trees stabilising riverbanks and sediment deposits forming new river forms, but they cannot be relied upon to bring about restoration in the short to medium term. Where willows colonise bed sediments their roots spread out first into the softest material, this means that roots are rarely put down into the hard bed. Trees may grow for several years until their canopies catch the wind, then entire stands of trees can be uprooted, lifting the rootbase from the riverbed and margins resulting in an overly wide channel once again (52.142397, 0.068192 pic 23). The supply of mixed grade substrates is required to bring permanent river restoration in combination with tree establishment.

Pic 23 – These willows (red arrows) had grown at the toe of bank, only to blow over resulting in channel widened once again.

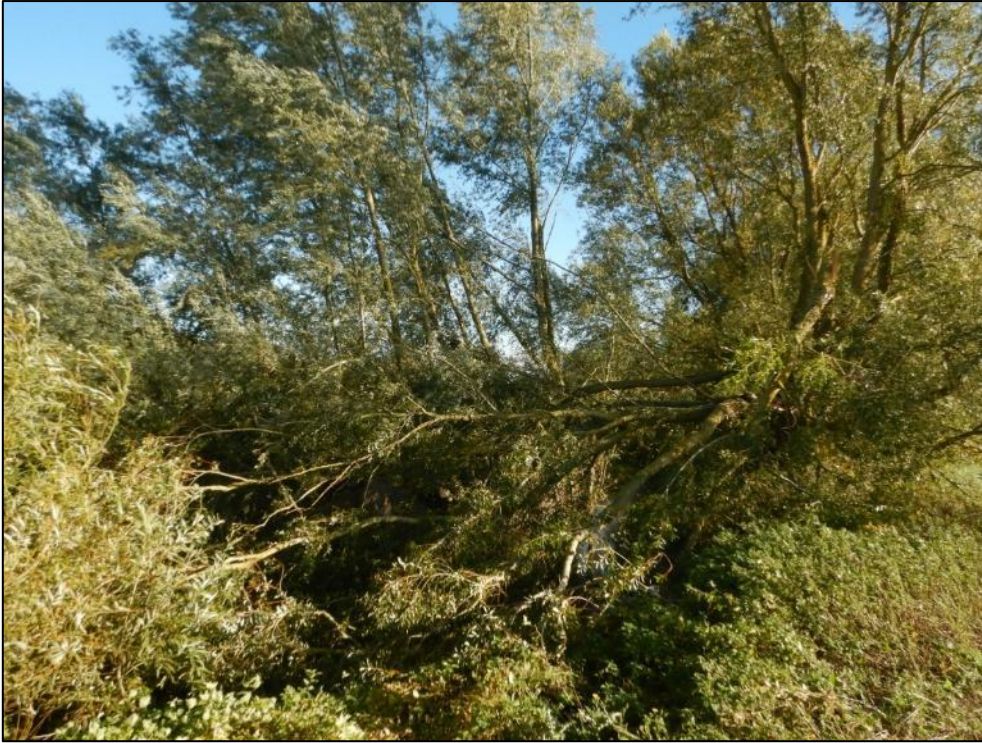
Considering willow management again, it was interesting to observe recent canopy fall (pic 24). Where “medium aged” pollard willows had been left they had multiple branches of the same diameter (and one would assume strength) and of great length. The wind had caught the branches to bring down a large number all at once. The oldest and largest pollard willows did not support a large number of long branches, instead they tended to have around five, with some having been lost as the tree has aged (beneficially lightening its load). Contrastingly, willows that had been left to grow naturally retained their strong central stem from which high branches grew of various diameters. This made them less susceptible to total collapse and didn’t cast dense shade like top-heavy mature pollards. Pollarding of willow trees is typical of the Cambridge area but if it cannot be sustained then its purpose and ultimate value should be reconsidered.

Pic 24 – Two or possibly more pollard willows had been left to grow tall with much canopy weight, unsurprisingly significant collapsed has occurred.

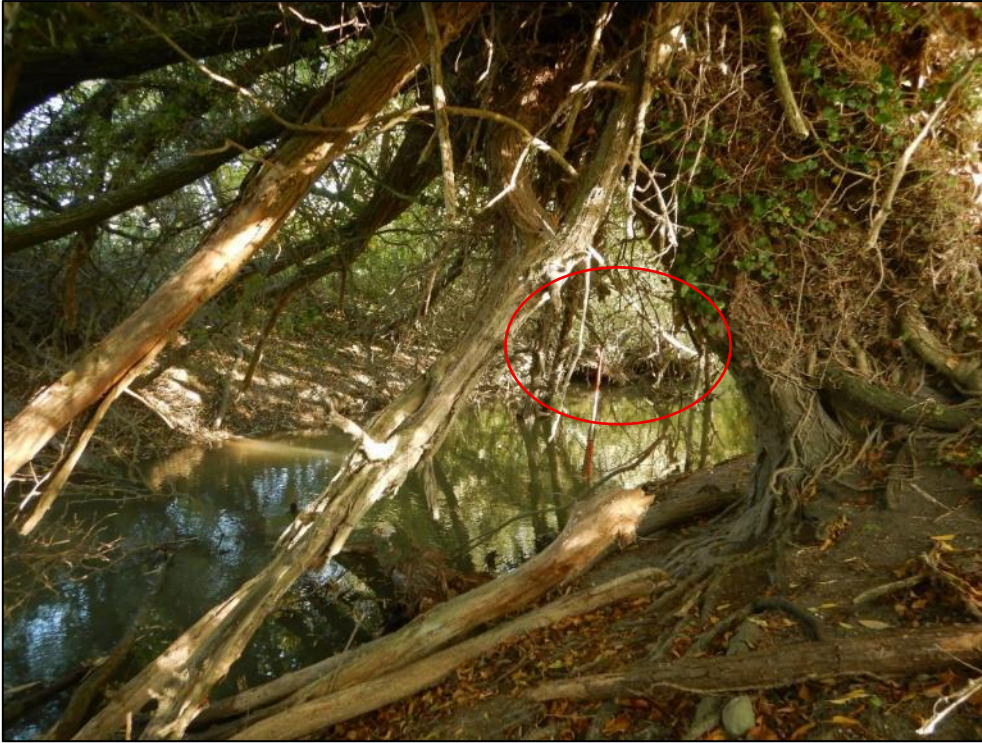
A massive collapsed pollard willow had been left unmanaged (52.143879, 0.066434 pics 25 & 26). Interestingly, with its limbs touching the ground they had re-rooted. This anchoring increased the tree's stability and its ability to uptake water and nutrients. This tree highlights the need to assess the reach's willows in winter when they can be properly viewed, and the need to produce a plan of willow tree management (which may include 'do nothing') and new planting to include further species.

Importantly, beneath this collapsed veteran willow the riverbed was relatively shallow at 0.6m and contained gravel. It could be possible that dredgers missed some areas of riverbed as they worked around important trees several decades ago. Whilst willow trees are recorded it would be useful to make a note of bed depths (or commission a topographical survey), it may become apparent that more parts of the river are shallower, presenting easier wins for restoration.

Pic 25 – A massive collapsed willow now supported by its branches. The branches have collected material (red ellipse) which provides flow deflection and cover to animals.
