WILD TROUT TRUST

Advisory Visit

River Rhee, Haslingfield, Cambridgeshire

October 2025

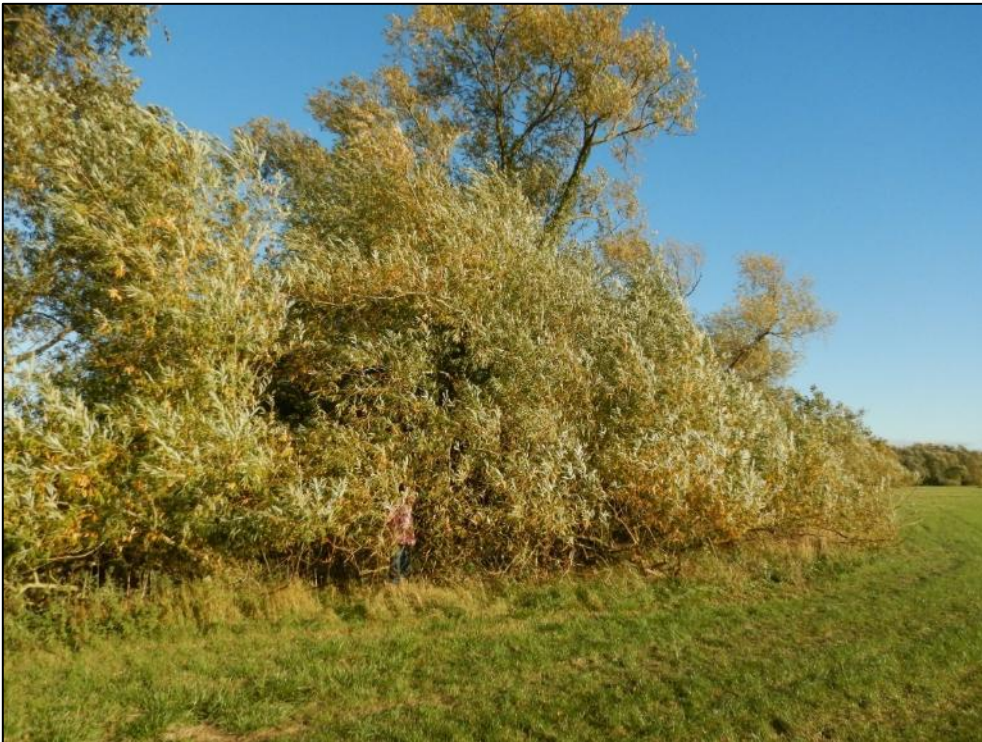
Pic 26 – The same tree as pic 25, note how wide it has spread with branches now rooted. This tree should be left unmanaged and not be re-pollarded.

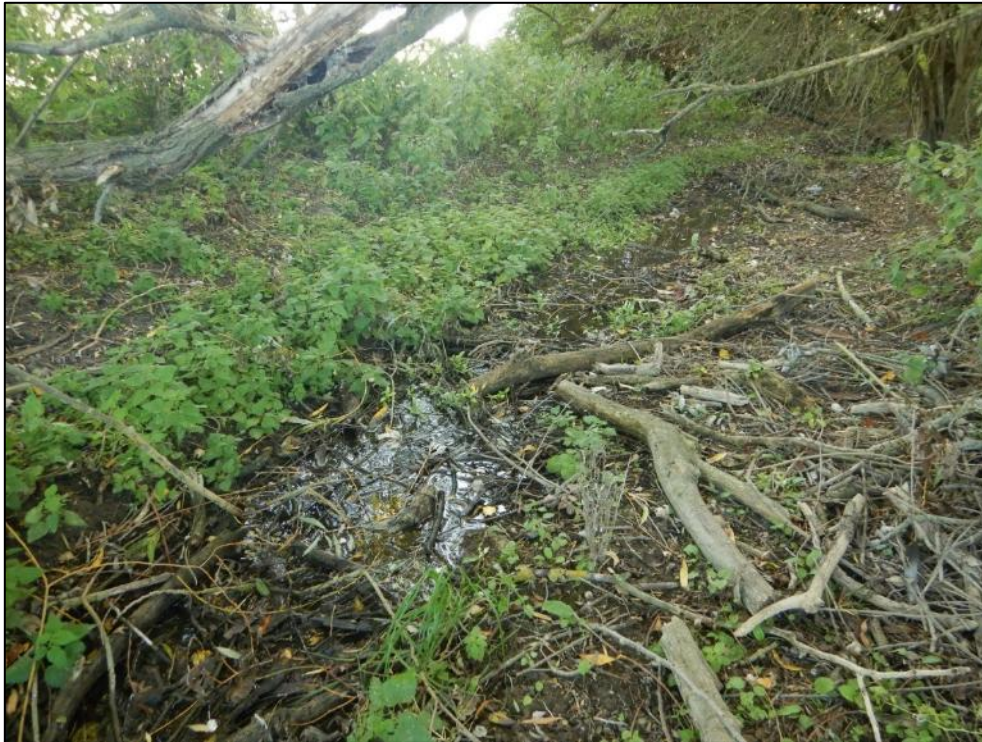
As Clock Holt was approached a small flush was observed (52.145173, 0.066214 pic 27). It was encouraging that it was still flowing in the drought. However, it was not a strong flow and is unlikely to provide a spawning area for fish. Much of its flow was seeping through the ground, with little

evidence of it ever having the energy to downcut its channel or scour away the excess of fallen wood.

Pic 27 – A flush entering from the side of Clock Holt.

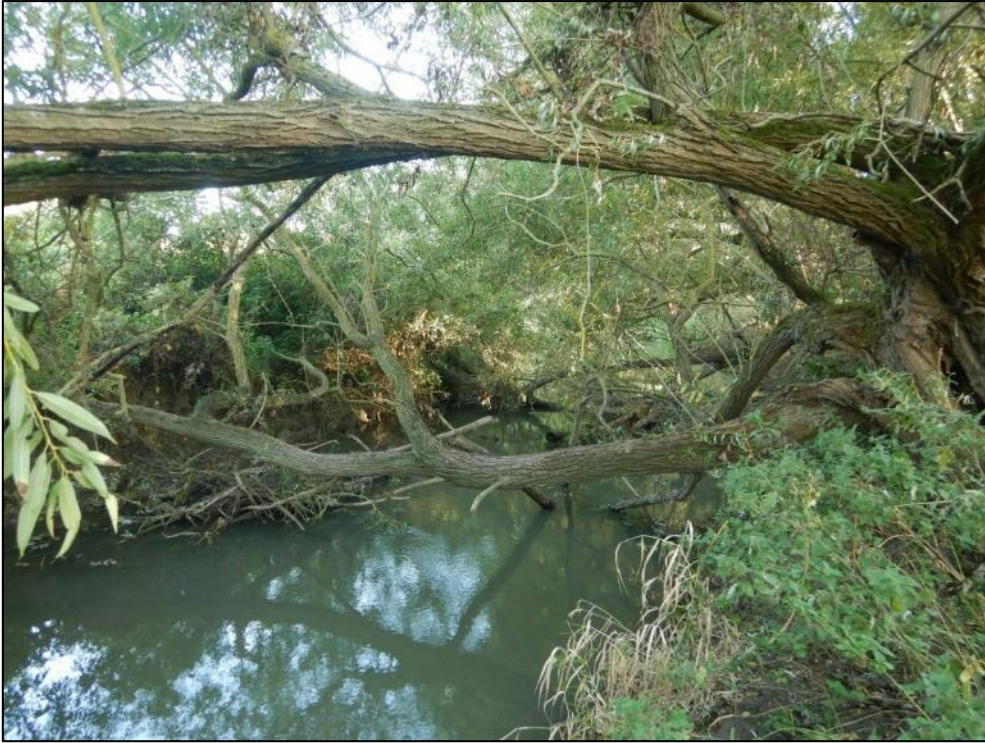
Clock Holt is a parcel of land owned by a Haslingfield charity (pic 28). A project idea was scoped for it back in 2011, including a backwater creation and gravel placement. The details are still held by the author and could be shared to the Friends.

Pic 28 – The view looking upstream from Clock Holt.

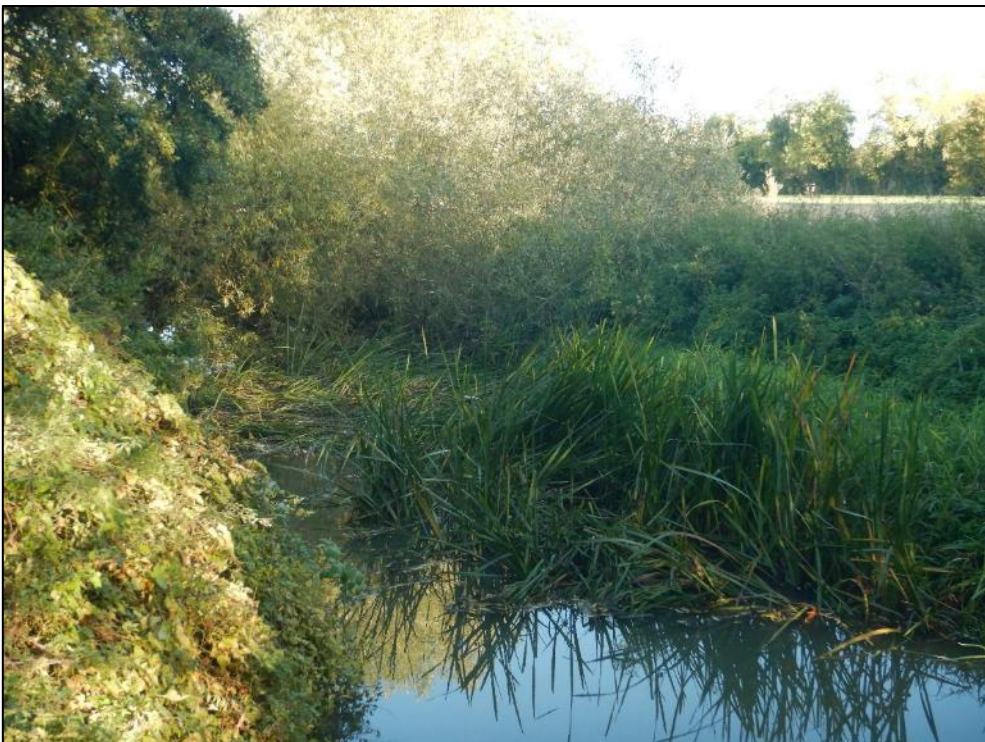
Downstream of Clock Holt the river appeared deep again. Bur reeds grew mid-channel suggesting little scouring of the bed in recent high flows. The river regularly overtops the lower right bank at this point. To initiate bed scour and cleansing of fine sediment, the bed needs to be raised with gravel and stone. It is also possible that the river is impounded by the Environment Agency's (EA's) gauging station at Burnt Mill.

Pic 29 – The river immediately downstream of Clock Holt (end of visit).
