WILD TROUT TRUST

Advisory Visit

River Rhee, Haslingfield, Cambridgeshire

October 2025

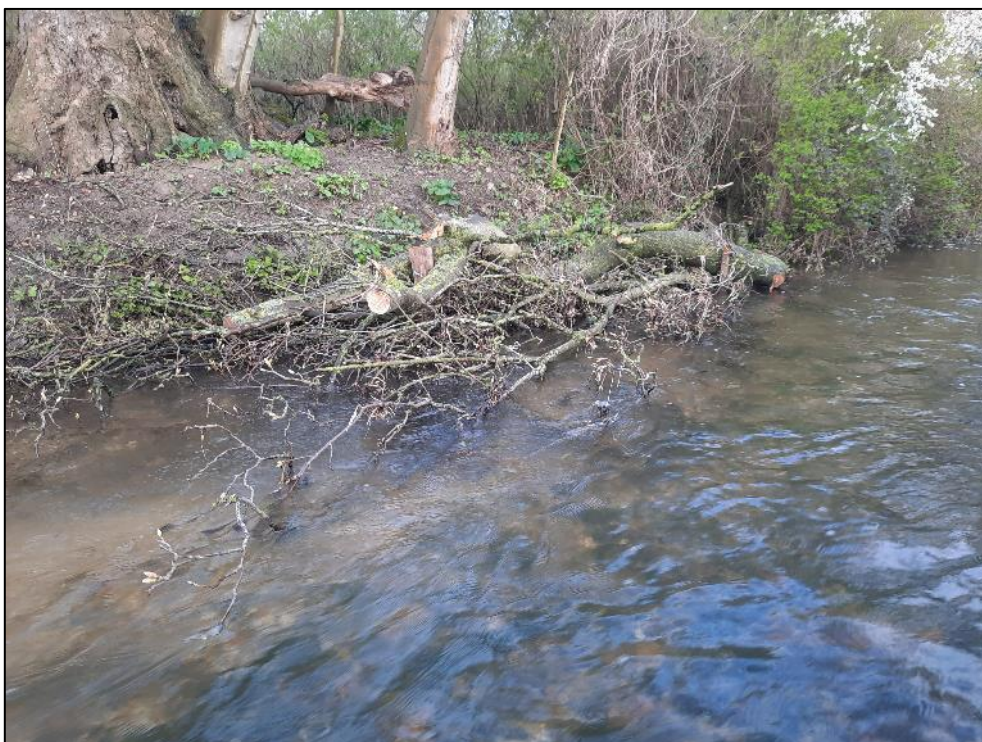
Pic 30 – Tethered and pinned wood in river margins can deflect flow creating small areas of scour, whilst the bulk of the woody material slows the flow and encourages fine sediment to be held. The complex cover also provides excellent protection for trout.

With permissions from landowners and the EA it may be possible for the WTT to train the Friends on habitat enhancement measures such as installing woody features, brush ledges and flow deflectors.

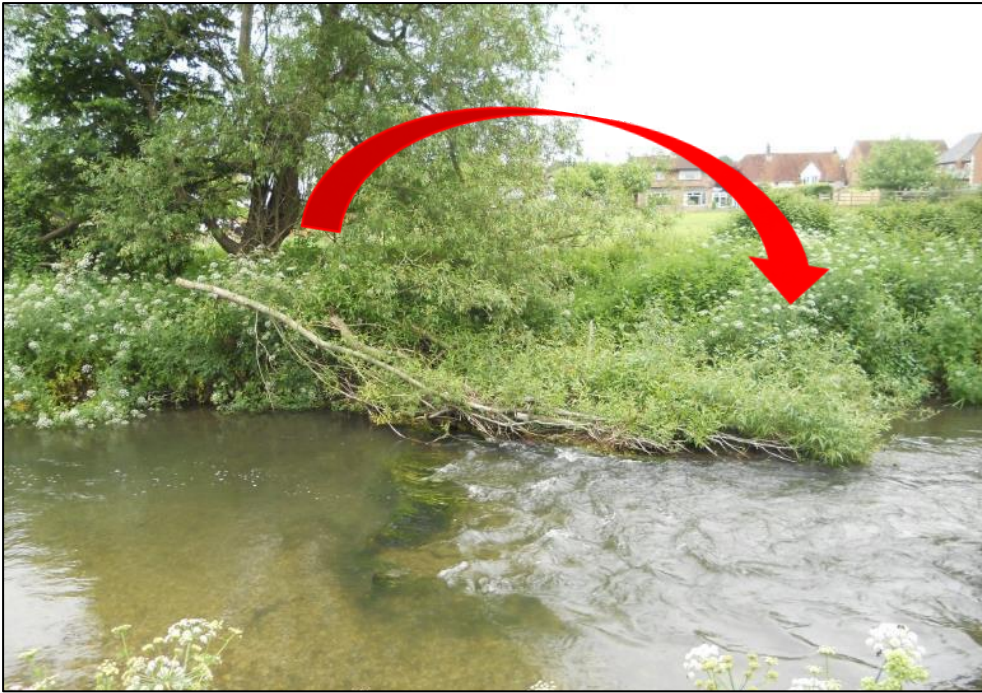
Pic 31 - Tree hinging, a simple and effective technique for increasing cover and flow deflection.

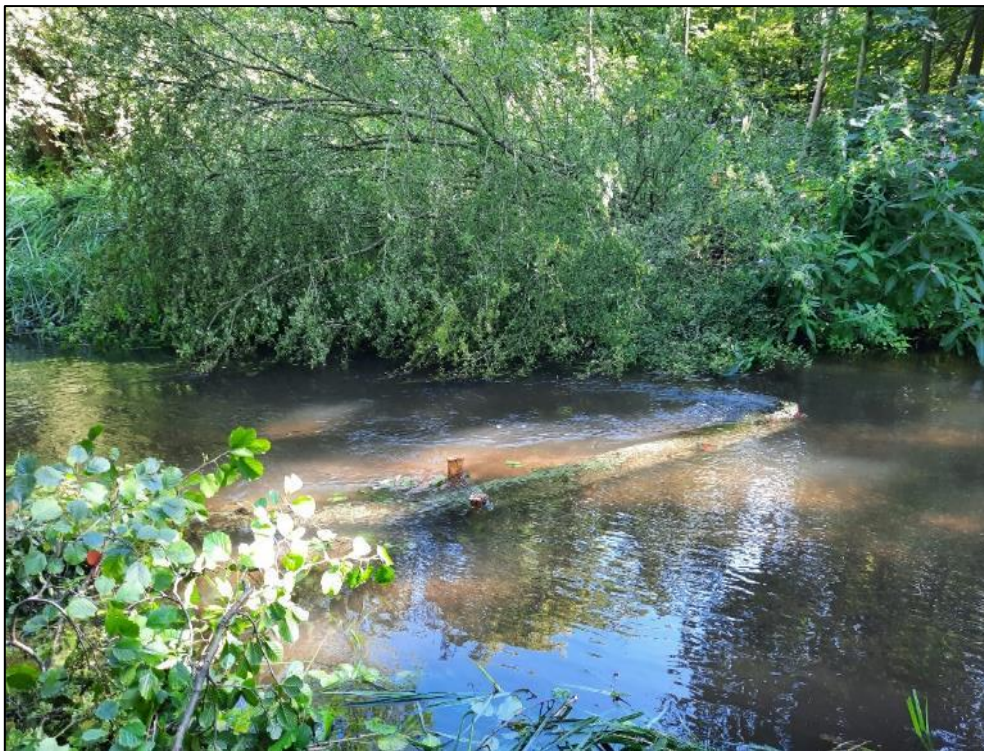
Pic 32 - A flow deflector used to focus flow and scour beneath a tree hinge-cut into the margins, providing excellent cover.
